BROOMALLS DAM

(NDS I.D. NO. 7 PA 00349,
DER I.D. NO. 23-9)

PHASE I INSPECTION REPORT
NATIONAL DAM INSPECTION PROGRAM

11 March 1980

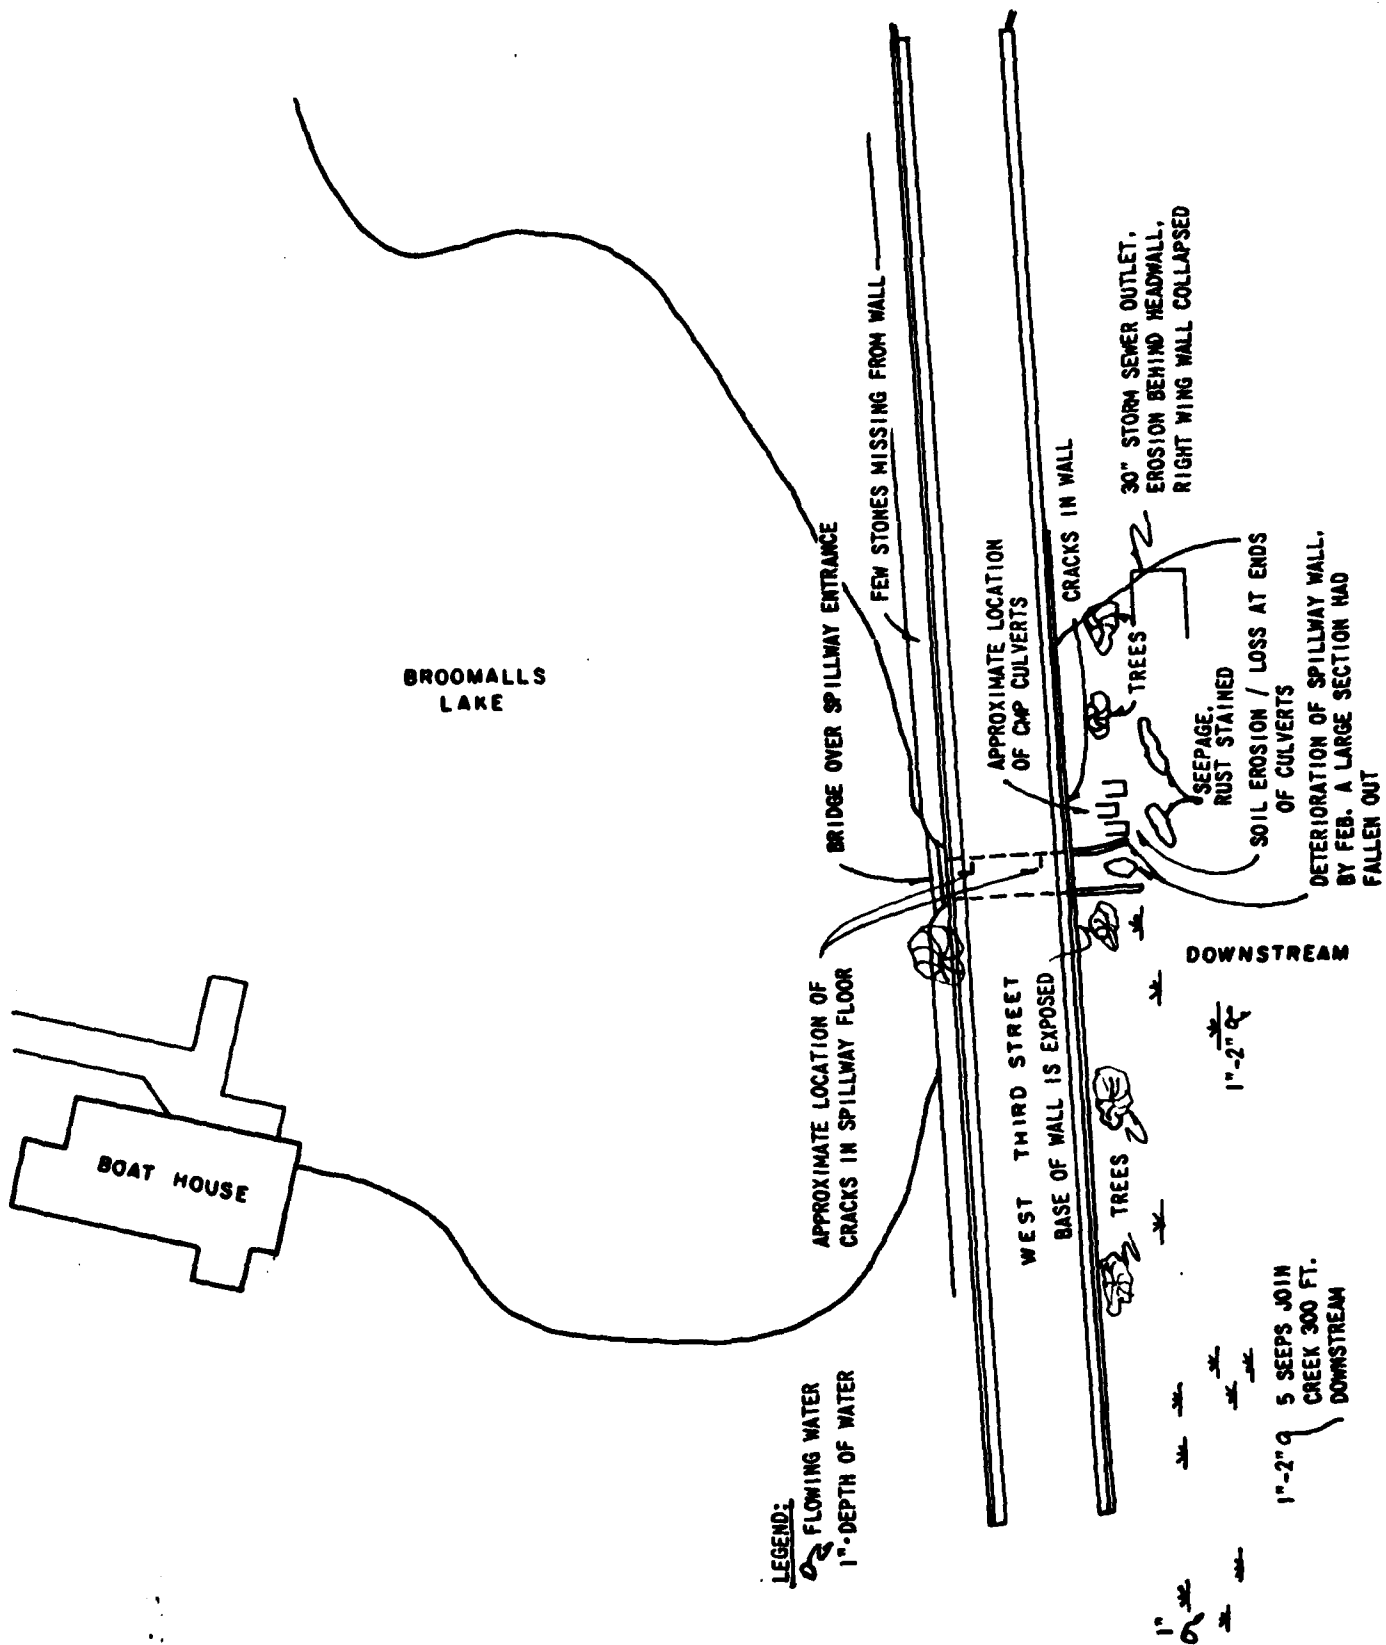
SHEET 5A OF 11

the downstream toe of the embankment to the right of the spillway are marshy areas which can be attributed to seepage under or through the dam embankment. No specific seepage was noted through the embankment to the left of the spillway; however, a good deal of rock is in the area and could mask any seepage. In February, the water level in the reservoir and downstream channel was lower and two seepage areas to the left of the channel were noted as shown on sheet 5a, Appendix A. Both seepage areas are rust stained.

FIELD OBSERVATION PLAN
BROOMALLS DAM
